SUBJECT: Report on Project Assessment of the Erbil City Transformers, Erbil, Iraq (Report Number SIGIR-PA-06-037)

**SIGIR PA-06-037**

**April 12, 2006**

## Erbil City Transformers Erbil, Iraq

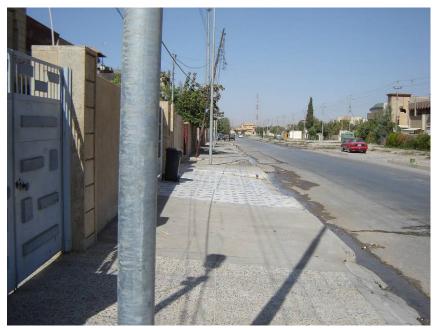
Prior to the start of the Erbil City Transformer project, the electrical demand in these areas in Erbil exceeded the supply. Erbil is one of the largest cities in northern Iraq, with an estimated population of almost one million people. The distribution system components required in GBAGH-009 were to be constructed adjacent to or near existing roads and city streets within residential and commercial areas around Erbil. Site Photo 1 shows a typical pole line location within a residential area.

Site Photo 1: Pole line location along city street in Erbil- Photo provided by USACE

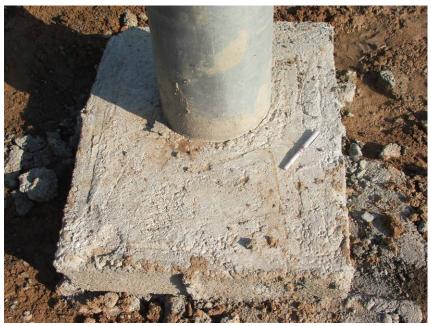
At ground level, the design also requires a concrete base around the pole to a height of not less than 100 millimeters (mm) above the ground surface. Although we did not review the pole placement during our site visit, a review of photographs and progress reports provided by the USACE RE indicate the contractor was excavating to proper depths. We did observe some of the concrete bases of the installed poles in the Hasarok area and they appeared to meet the 100 mm specification requirement. To see one of the galvanized pole concrete bases, refer to Site Photo 2.

Site Photo 2. Concrete base encasing the steel tubular pole

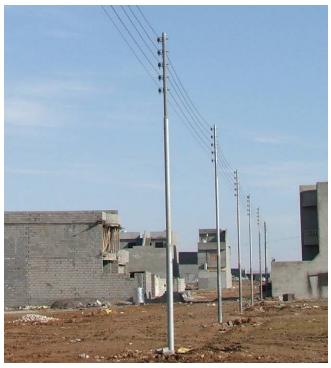
In the Hasarok area, we observed both pole sizes and verified the poles were the appropriate types for the medium and low voltage conductors. Site Photo 3 shows a 9 m pole line partially constructed, carrying low voltage conductors. Site Photo 4 shows a series of 11 m poles that carry 11kV conductors supported by the cross arm near the pole cap. The poles in Site Photo 4 are also carrying 400V/230V conductors attached just below the cross arm.

Site Photo 3. 9 meter poles with low voltage conductors attached

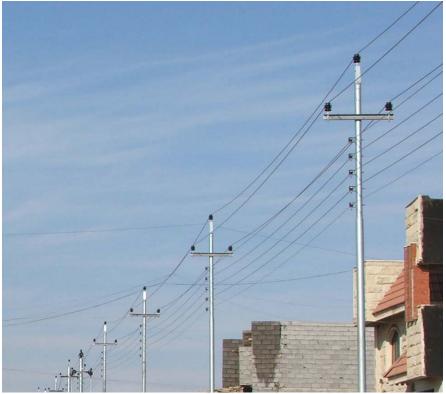
Site Photo 4. Pole line with medium and low voltage conductors

The design sets maximum pole spacing for pole lines parallel to the road. The maximum spacing for low voltage conductors on 9 m poles is 45 m. For combination poles with 11kV conductors and low voltage conductors, the maximum spacing is 35 m. Based on our observations, the pole lines in the Hasarok area met the requirements for pole spacing.

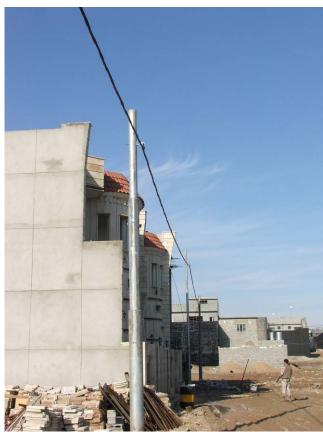
The design specifications suggested the use of ABC lines when close to buildings or in congested lanes when bare conductor cannot be installed. The design also establishes vertical and horizontal clearance requirements for the cable. Site Photo 6 shows an example of one of the ABC lines run in the Hasarok area. The ABC line in this area met the vertical and horizontal clearance requirements.

Site Photo 6. ABC line in Hasarok area in Erbil

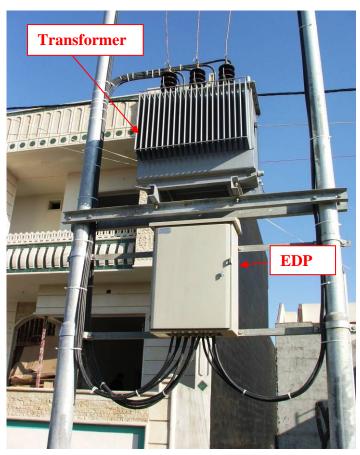
As of 18 January 2006, according to records provided by the USACE RE, 55 of 110 transformers on the Erbil City Transformer project had been installed and 44 had been energized. There were several transformers and low voltage distribution panels installed in the Hasarok area when we toured the site. Site Photo 7 shows one of the 11kV - 400V/230V transformers we examined.

Site Photo 7. Transformer and low voltage electrical distribution panel (EDP)

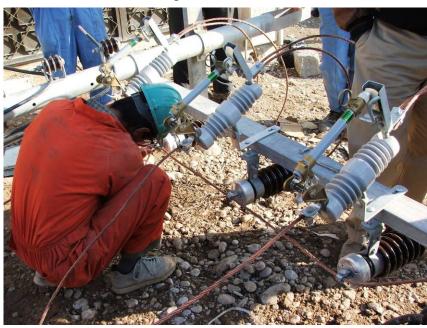
During our site visit, the contractor was preparing one H-pole on the ground prior to setting it in place. Site Photo 9 shows the contractor working on the three fuse cutouts. The contractor at that time was also tying off the insulated low voltage cable to each of the two sides of the H-pole.

Site Photo 9. Preparing fuse cutouts on H-Pole prior to setting

Based on our observations, contract work on the transformer and low voltage distribution panel installation met the design and specification requirements.

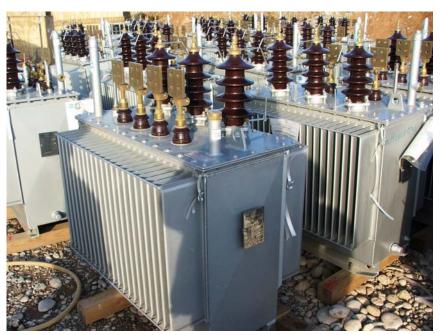
In addition to Hasarok, the assessment team also visited the contractor's material storage facility located in another area in Erbil. There, we viewed the remaining transformers as seen in Site Photo 10. We examined transformer factory plate data, and verified that the transformers met contract requirements.

Site Photo 10. 11kV - 400V/230V transformers at contractor's storage facility
